DELAWARE RIVER BASIN

SCS PA 477
BERKS COUNTY, PENNSYLVANIA

NDS I.D. NO. PA 00720
DER I.D. NO. 6-457

PHASE I INSPECTION REPORT
NATIONAL DAM INSPECTION PROGRAM

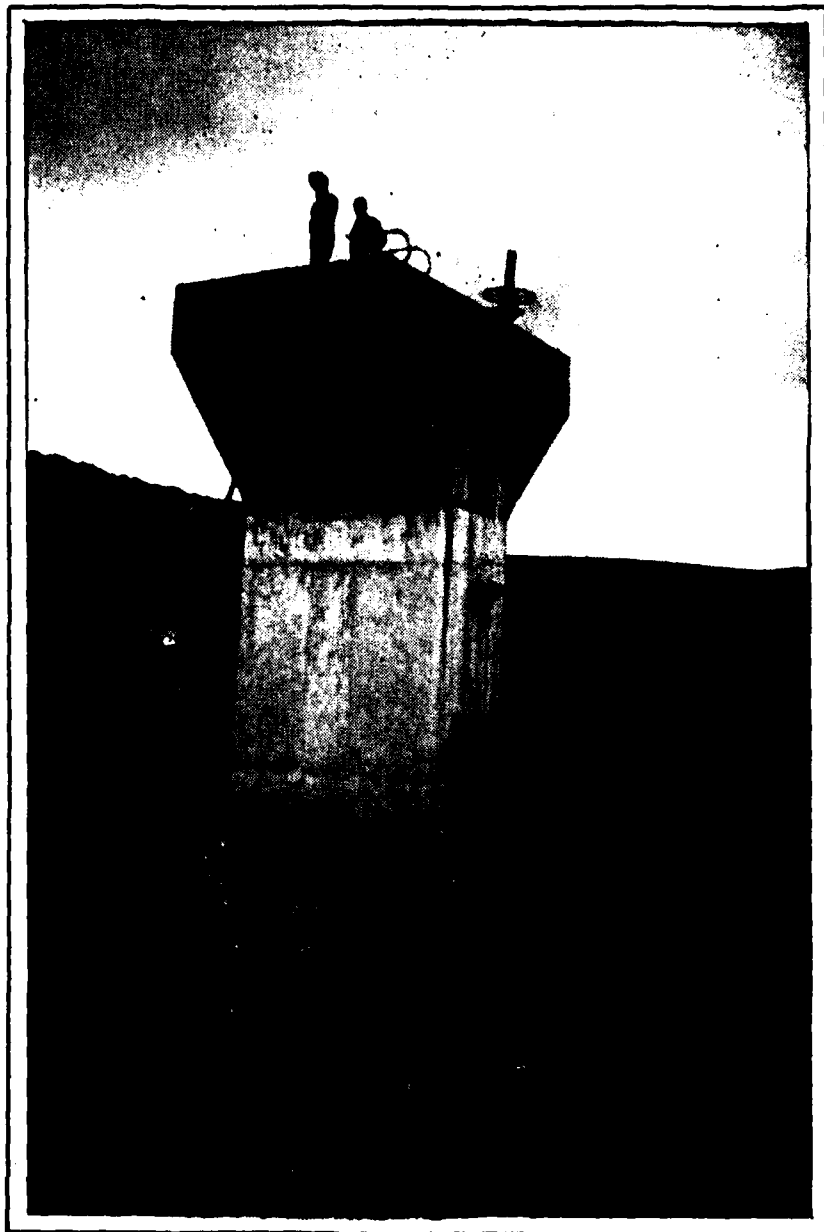
PHOTOGRAPH NO. 1

1. Principal Spillway. As shown on Photograph No. 1, the riser is located within the upstream berm at the shoreline. Exposed portions of the riser were inspected and evaluated to be in good condition with no signs of excessive concrete deterioration, spalling or other structural deficiencies or defects. The interior of the intake riser could not be inspected as one hinge was rusted on the access door and the door could not be opened. The pond drain sluice gate was exercised and found to operate easily.

VIEW OF PRINCIPAL SPILLWAY
RISER. ALSO NOTE WILLOWS IN
FOREGROUND AND WOODY VEGETATION
ON EMBANKMENT BEHIND RISER.

2. The growth of willows should be removed from the embankment shoreline. Cutting is not sufficient to prevent the growth of willows.
3. The access door from the top of the riser should be repaired or replaced, as necessary.

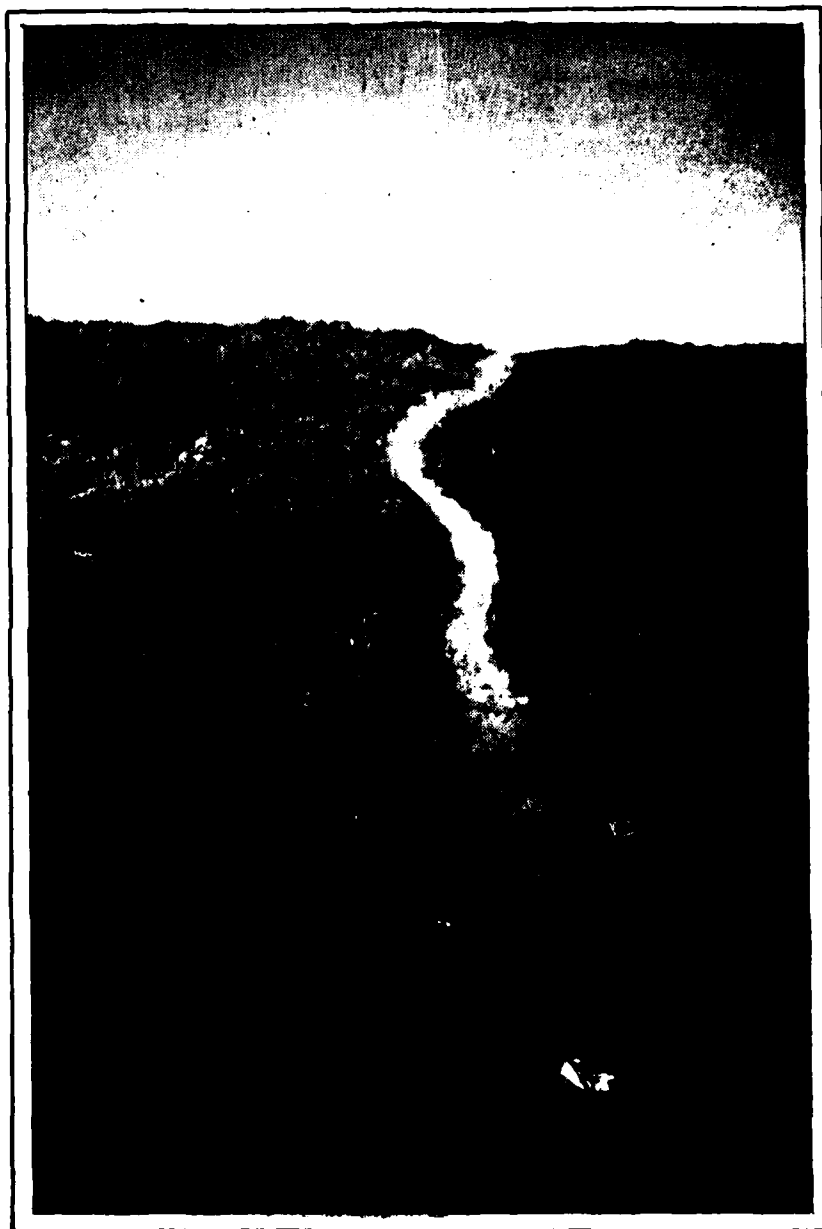
PHOTOGRAPH NO. 8

PATH FROM U.S. ROUTE 22 TO
TOP OF EMBANKMENT. NOTE
MULTIFLORA ROSE TO THE RIGHT
OF THE PATH.

1. All saplings and woody vegetation should be removed from both the upstream and downstream slopes of the embankment.
2. The multiflora rose should be removed from the drainage swale between the embankment and the highway to prevent the spread of the multiflora rose to the embankment.
3. The growth of willows should be removed from the embankment shoreline. Cutting is not sufficient to prevent the growth of willows.
4. The access door from the top of the riser should be repaired or replaced, as necessary.

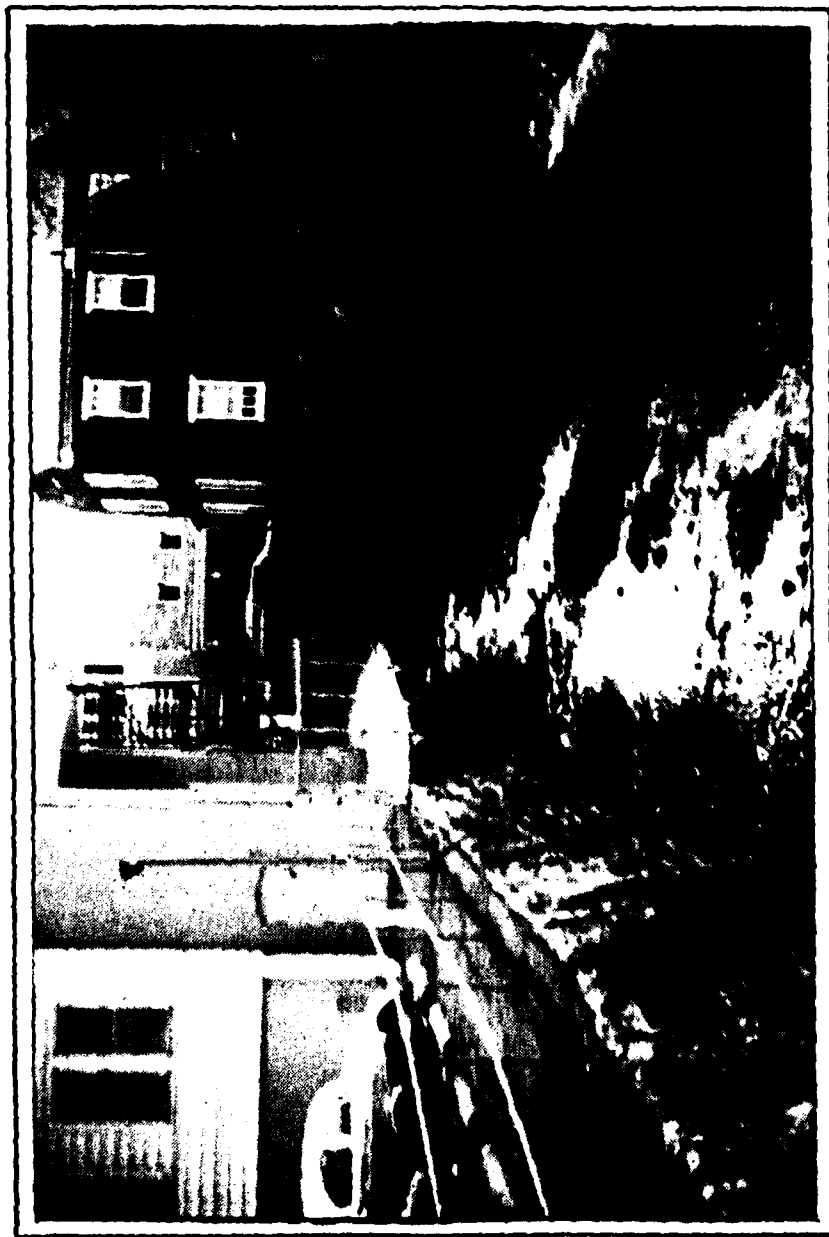
PHOTOGRAPH NO. 12

TYPICAL VIEW OF DOWNSTREAM DAMAGE
CENTER IN HAMBURG, PENNSYLVANIA.
